POST-MARKET EVALUATION FOR THE SAFETY AND EFFECTIVENESS OF BREAST IMPLANTS

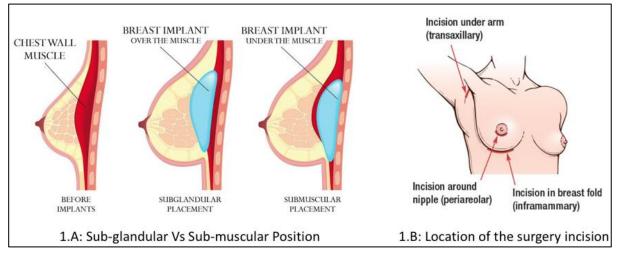
FIGURE 1: BREAST IMPLANTATION CLASSIFICATION IN ACCORDANCE TO THE IMPLANT (A) AND THE INCISION (B) POSITIONS.

Breast implants are medical devices that consist of a gel-like material in a flexible sac that take the shape of the female breast, as shown in figure 1. They are implanted surgically under the breast tissue (sub-glandular position) or under the chest muscle (sub-muscular position), where incision can be made under the breast fold (inframammary), under the arm (transaxillary), around the nipple (periareolar), or through the mastectomy scar, for reconstruction implantation, as shown in figure 1.A and 1.B. [1] Breast implant can be used to increase the breast size (breast augmentation), or to reconstruct the breast tissue, usually after mastectomy (breast reconstruction).

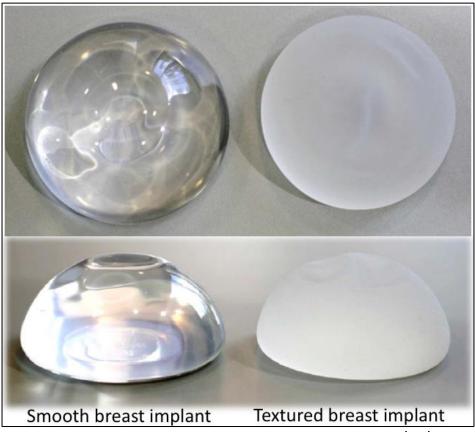
FIGURE 2: BREAST IMPLANT CLASSIFICATION IN ACCORDANCE TO THE OUTER-SHELL SURFACE: SMOOTH (LEFT) AND TEXTURED (RIGHT).

Breast implants are classified in accordance to the outer-shell surface into smooth and textured breast implants, as illustrated in figure 2. Textured breast implants are further sub-classified, based on surface area characteristics and measurements, into four types; nano-texture, micro-texture, macro-texture, and macro-texture-plus. [2]
